TITLE: AGUSTA Experience on Damage Tolerance  
Evaluation of Helicopter Components

## AGUSTA Experience on Damage Tolerance Evaluation of Helicopter Components

Ugo Mariani – Fatigue Office  
Luigi Candiani – Accidents Investigation Office

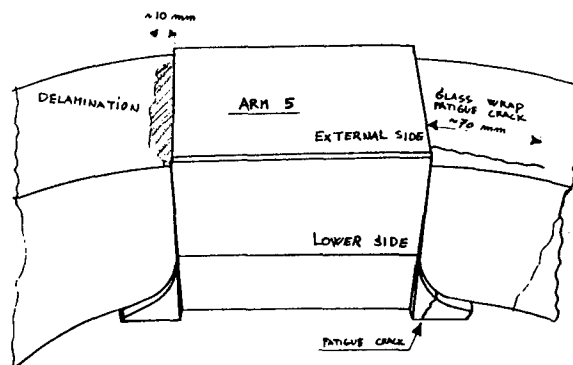
Figure 4 - M.R. Hub Damages after Safe Life Test

In addition, scratches and delaminations in the glass wrap due to amplified loading of safe life test showed a slow flaw growth behaviour in the start-stop cycles of the D.T. testing phase, and no damage growth at flight loads, figure 4. The test achieved the target of 10.000 hours for the Navy spectrum, the most severe for the higher start stop loads due to the blade folding cycle, proving a safe inspection interval of 2500 hours using a life safety factor of 4.

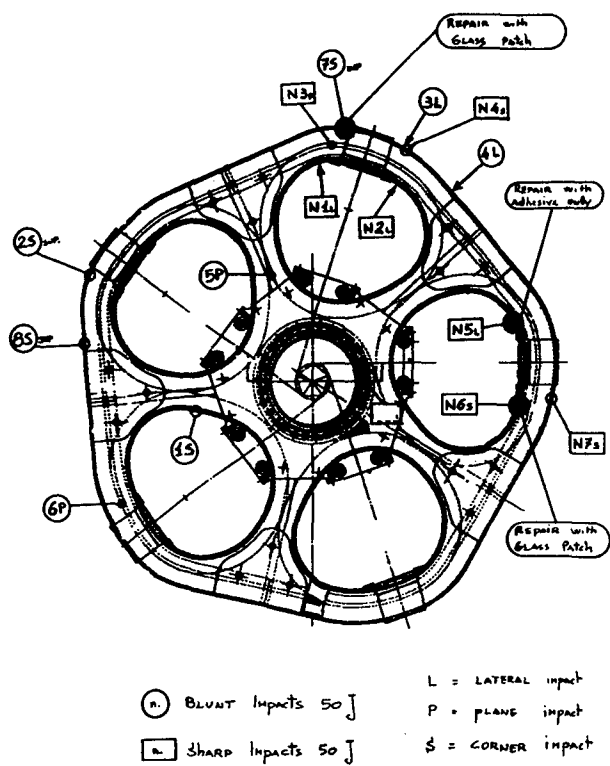
Figure 3 - M.R. Hub Impact Damages

No damage growth in the service life was proved by tests in composite parts, which were impacted for Barely Visible Impact Damage (BVID) at energy of 50 J with a spherical impactor  $\phi=25$  mm, and for Clearly Visible Impact Damages (CVID) with a sharp tool made by a 90° pyramid, figure 3.

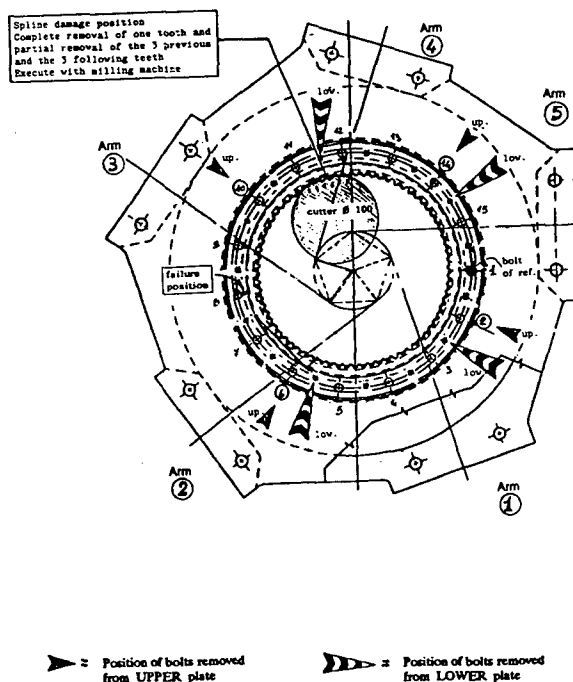
Figure 5 - Flaws in M.R. Hub Splined Coupling

After the safe life test, tolerance to fretting and fail safe capabilities in the titanium core were checked removing the solid lubricant and 10% of the Hub teeth in the splined coupling with the M.R. Mast and testing at amplified Torque, figure 5. The test achieved the Civil variant design target of 40.000 h for the start-stop torque loading cycles, proving also no high frequency fatigue damage by the S/N curve for the fretting failure mode. A mean strength reduction by 2 standard deviations, appropriate for Enhanced Safe Life approach, was used instead of the normal reduction by 3 standard deviations for pristine components, considering the structural redundancy demonstrated and the relevant flaws under test.

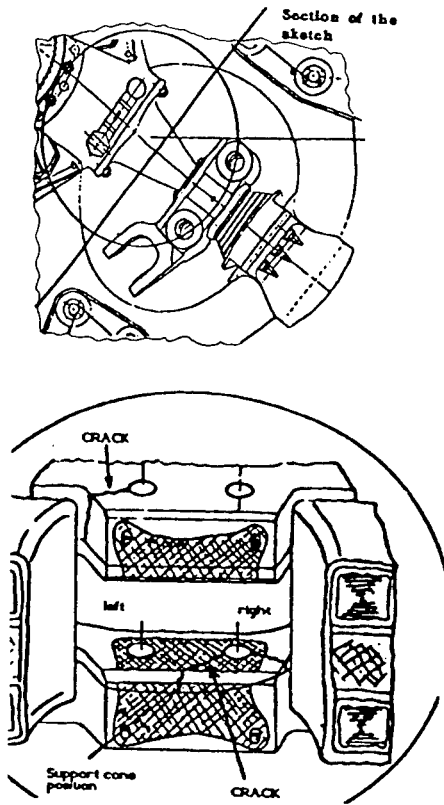
Figure 6 - M.R. Hub Flaws in Aluminium Plates and Titanium Core

Flaw Tolerance capabilities of the Aluminium Upper and Lower Plates was checked removing 4 out of 15 bolts on both plates in the splined area and testing the Support Cone coupling area with relevant cracks and fretting due to the initial safe life phase of testing, figure 6. The Al Plates proved fail safe capabilities for bolts failures achieving the target for both Civil and Navy usage spectra and proved in addition more than 1000 hours of Enhanced Safe Life for the Support Cone coupling area with severe fretting and cracks. The pristine component has unlimited fatigue life and this evaluation could be used to improve the evaluation of inspection intervals in service for Clearly Detectable Damages.

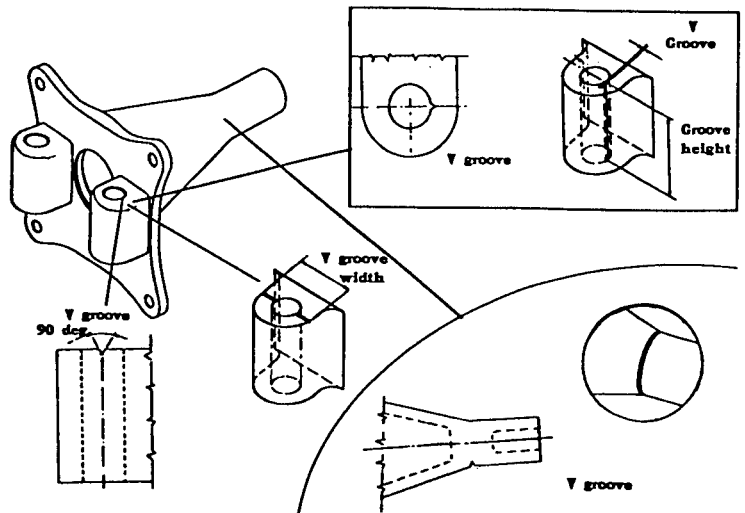
Figure 9 - M.R. Hub Support Cone - 'V' grooves of flawed components for fatigue tests

- the Stud Bolts failure, which was proved as not fatigue critical due to redundancy of the two Special Bolts
- fretting of the Special Bolts
- fretting in the lugs of the Special Bolts
- flaws in the lugs of the Special Bolts, simulating flaws that could be done during assembling and maintenance operations, figure 9. Flaws made by 'V' grooves of 0.35 and rogue flaw 0.50 mm dept were made in the test components using a sharp tool to minimise plastic deformation at the flaw tip. Constant amplitude loading tests were carried out to determine the Wohler curve of the flawed specimens for the 'Enhanced Safe Life' calculations.
- the same flaws were made also in the cylindrical part of the Support Cone, for simulation of improper manufacturing or maintenance operations.

The rogue flaw in the lug reduces the fatigue strength of the pristine components by 1.25, the flaws in the other sections did not show relevant fatigue strength reduction. The Enhanced Safe Life evaluation for surface flaws in the lug did not show any additional fatigue life reduction. Figure 10 shows the fatigue test data.

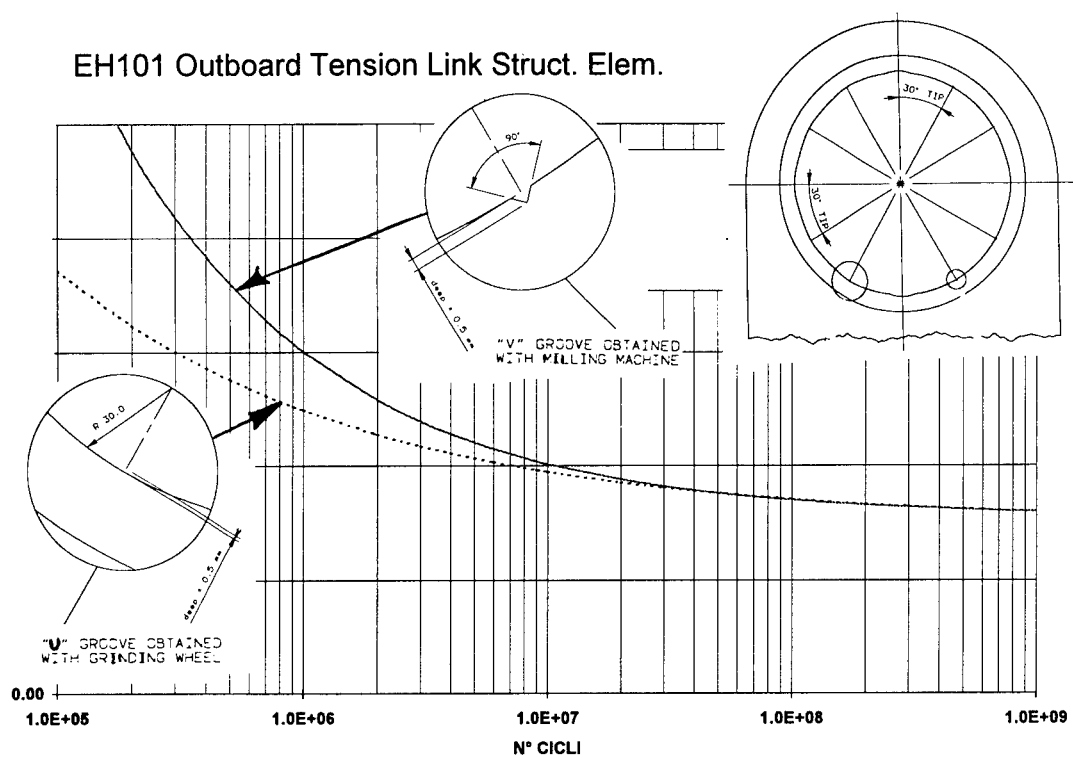
Figure 12 – Titanium Lug Elements - Flaw Tolerance Data

Full size lug structural elements were tested for evaluation of fatigue strength reduction due to rogue flaws in the lugs of the folding section. The specimens were flawed by 'V' grooves 0.5 mm deep, made by milling machine, simulating severe scratches in the lug contact sections. The scratches did not reduce the fatigue strength if they were made out of the net-tension area. An additional type of flaw was evaluated considering improper repair, simulated in the lug elements by 'U' grooves made by grinding wheel. The test data proved a relevant fatigue life reduction, but without additional reduction of the endurance value. Figure 12 compares the Wohler curves.

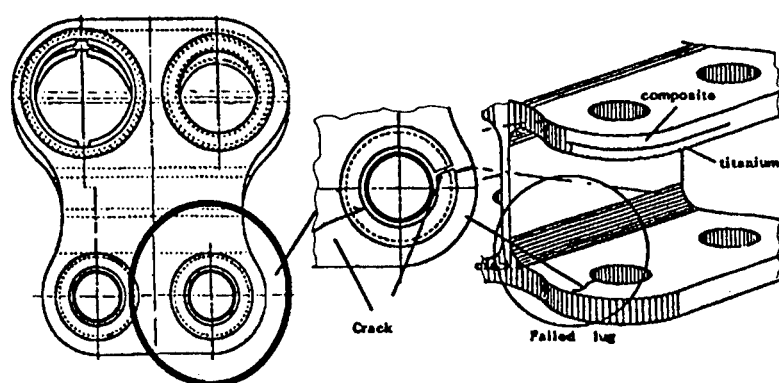
Figure 13 - M.R. Outboard Tension Link fatigue crack of the titanium lug

Full size tests of the Outboard Tension Link verified the capability of the composite plate to provide a redundant loading path after local failure of the titanium lug, figure 13, proving at least 40 hours of fail safe capabilities at maximum flight loads and residual static strength up to limit loads. An Equivalent capability is expected by the outer lug section of the Inboard Tension Link.

In both components the fatigue crack in the titanium lug is detectable by detailed inspection.

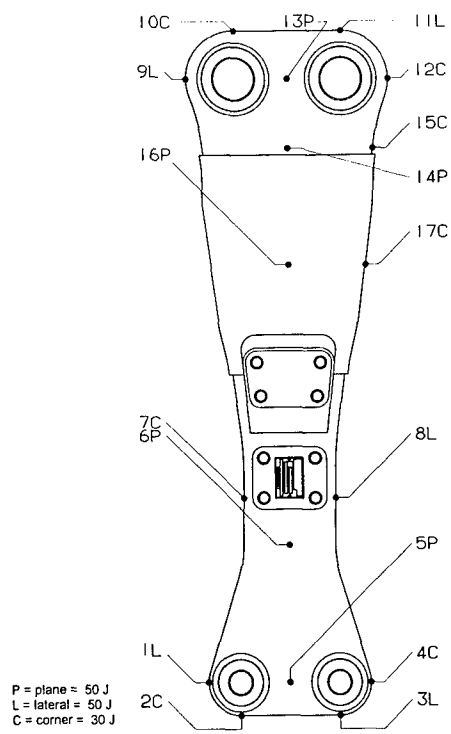
Figure 14 - M.R. Civil Tension Link Impact Damages for D.T. Test

Tolerance to CVID by sharp impact at 50 J was additionally proved by full size test for 500 flight hours with residual static strength test up to limit load, figure 14.

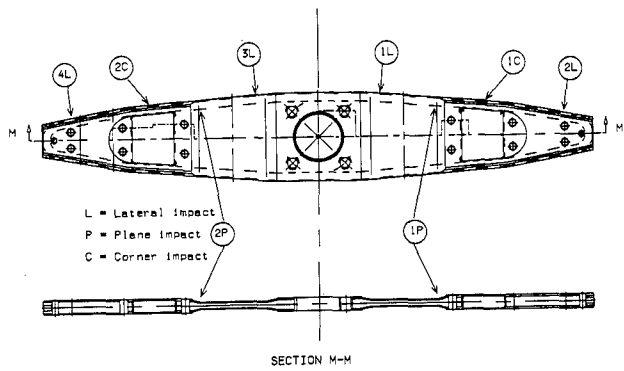
Figure 16 – Tail Rotor Hub Impact Damages for Test

The Tail Rotor Hub is made by a carbon fibre-epoxy loop windings with internal glass-epoxy plates, wrapped by a glass-epoxy cross ply. The Flaw Tolerance to 50 J impact damages, figure 16, manufacturing discrepancies and environmental ageing was proved by tests to address the retirement life, proving also ultimate load static strength after fatigue in hot-wet ageing.

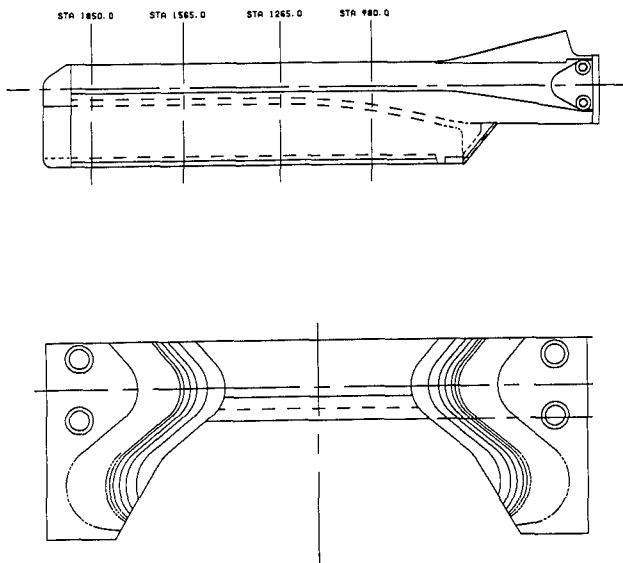
Figure 17 – Tail Rotor Blade D.T. of Trailing Edge

The Tail Rotor Blade is made by carbon fibre-epoxy. In addition to the Flaw Tolerance evaluation of the Spar, considering BVID up to 50 J, manufacturing discrepancies and environmental ageing, a specific test was carried out to address the fail safe capability for large cracks in the trailing edge skin, covering 10 flight hours of spectrum test factored for scatter and environment with the trailing edge removed from the specimen, figure 17. Residual static strength was then proved up to limit load.

A daily visual inspection for cracks in the trailing edge was required, without any special tool, covering the accidental damage on the blade skin.

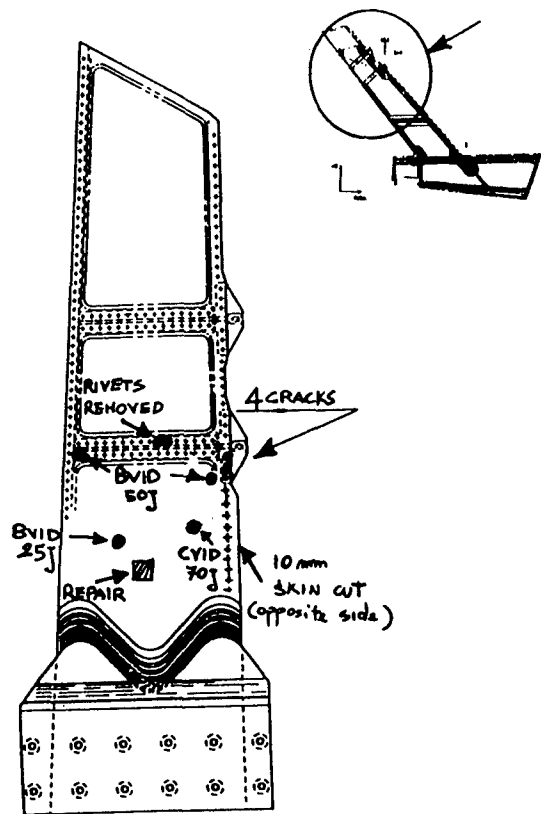
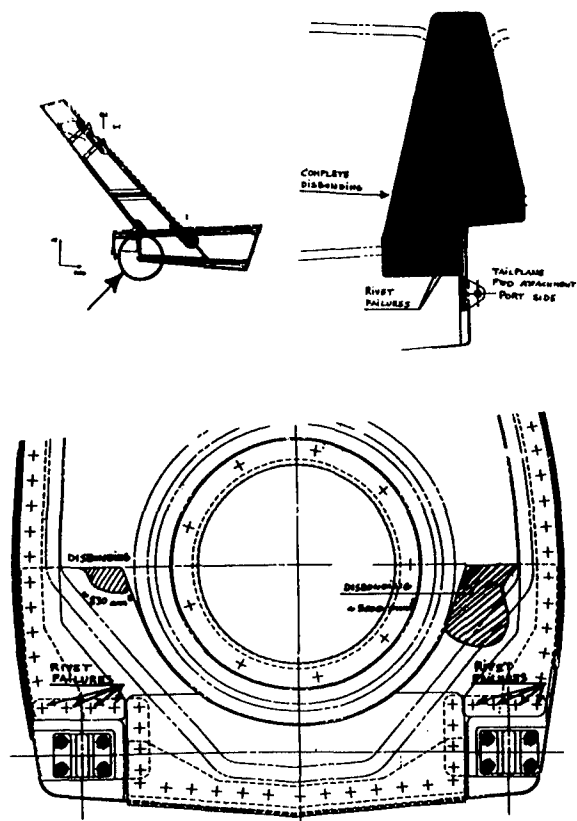
After local failure caused by safe life tests, subcomponents were fatigue tested to evaluate their tolerance to delaminations, disbondings, rivet failures and cracks in the skins or in the metal attachments caused by amplified loading or intentionally done after the basic fatigue tests.

These tests were related to the vertical fin and the tailplane attachments area, figures 20 and 21. They proved no flaw growth or redundancy of the loading path in sections of load concentration.

An inspection interval of 600 flight hours was proved for Clearly Detectable Damages.

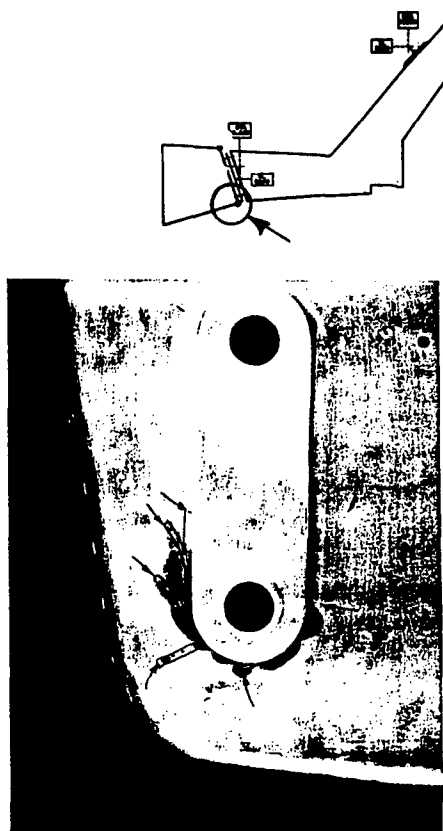
Figure 19 – Civil Rear Fuselage – End Fittings Slow Crack Growth

The equivalent subcomponent for the Civil variant showed 500 hours of slow crack growth for fatigue crack starting from the fillet of the boss in the development configuration, figure 19. Inspection by Ultrasonic can detect the crack with the Tail Unit installed.
